Detection of Collapse Position in Mountainous Slope by Underground Sound Method

Synopsis

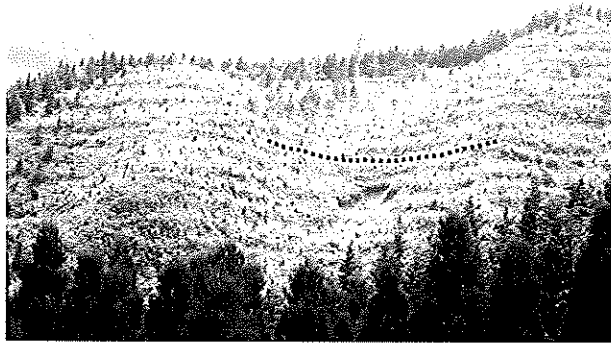
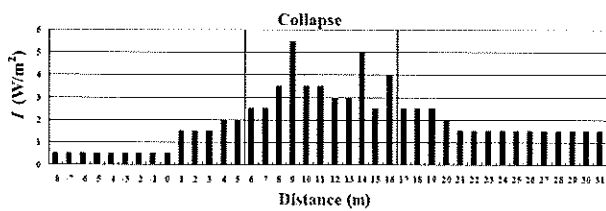
[1] Natural slope A (photo 6, Fig. 8)

Photo 6 Collapse in natural slope A

Fig. 8 Distribution of the underground sound in natural slope A

Natural slope was catchments landform, and had one collapse. Width of collapse was 10m, depth was from 1m to 1.5m. Soil mass above the bedrock was collapsed. These were no spring when this site was inquired.

The underground sound in collapse position was bigger than another positions. And, Collapse position had 3 sound peaks. The collapse was divided into three blocks in photograph 6. And, each blocks was corresponding to each sound peaks.

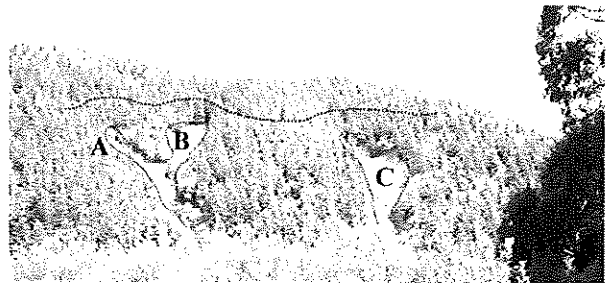
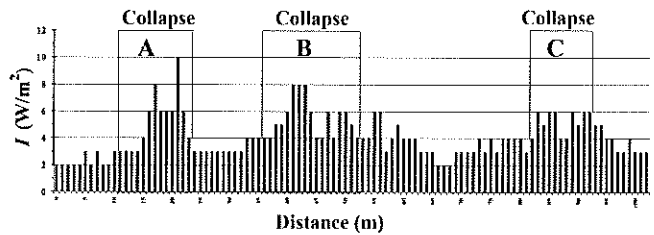
[2] Natural slope B (photo 7, Fig. 9)

Three collapses were occurred in 14 age of Japanese cedar forest. The geographical feature was catchments. Collapse A was 12m in width, and 2.0m in depth. Collapse B was 16m in width, and 2.0m in depth. Collapse C was 10m in width, and 1.0m in depth. All collapses were occurred on the bedrock as a boundary.

Photo 7 Collapse in natural slope B

Fig. 9 Distribution of the underground sound in natural B

The underground sound in collapse position was bigger than other positions. And, collapse B and C was divided two blocks in scarps. Correspondingly, these collapse had two underground sound peaks. The collapse positions and the underground sound peaks were adjusted even when the pond did not exist.

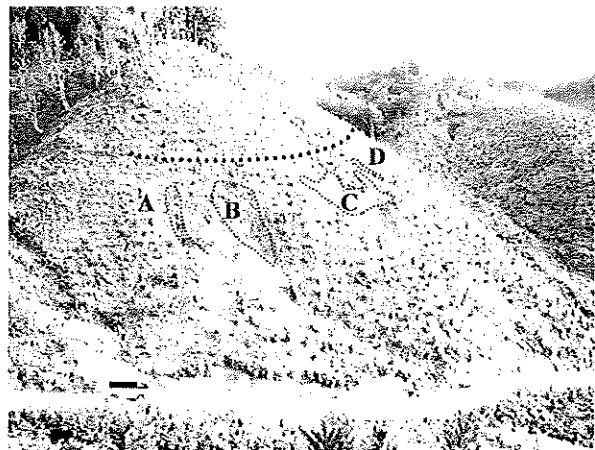
[3] Natural slope C (photo 8, Fig. 10)

Photo 8 Collapse in natural slope C

Four collapses occurred in natural slope C. The geographical feature was ridge. Collapse A was 2m in width, and 1.0m in depth. There was one spring under the collapse. Collapse B was 6m in width, and 1.0m in depth. There were two springs under the collapse. Collapse C that was collapsed the soil mass above the bedrock was 12m in width, and 1.0m in depth. This collapse had no spring. Collapse D was 2m in width, and 1.0m in depth and also had no spring.

The underground sound in collapse position was bigger than another positions. And, there were two sound peaks in collapse B that had two springs

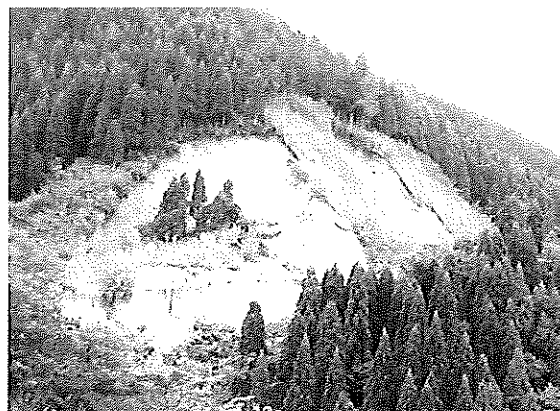
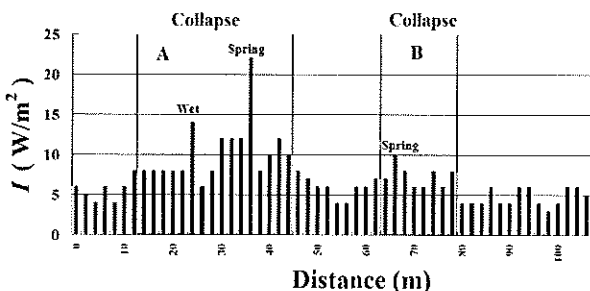
[1] Road cut slope A (photo 9, Fig. 11)

Two collapses occurred in ridge of forest road. Collapse A was caused by typhoon No.23 in 2004. Collapse B was caused by typhoon No.21 in 2004. Collapse A was 30m in width, and 5.0m in depth. One spring and wet zone were detected in the investigation immediately after the collapse. Collapse B was 14m in width, and 1.0m in depth. One spring was detected in the investigation immediately after the collapse.

The underground sound in collapse A and B were bigger than another positions. And spring and wet zone in collapse A were corresponded with underground sound peaks. The under ground sound between collapse A and B was smaller than under ground sound in collapse A and B.

Photo 9 Collapse in road cut slope A

Fig. 11 Distribution of the underground sound in road cut slope A

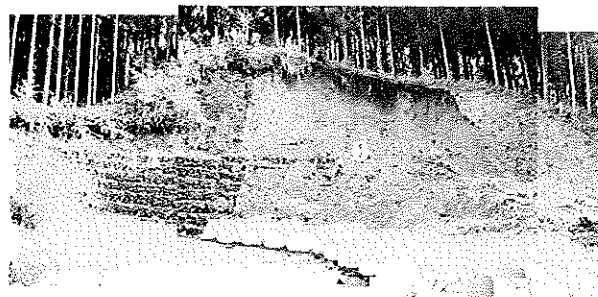
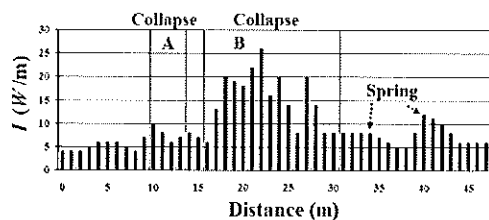
[2] Road cut slope B (photo 10, Fig. 12)

Two collapses were occurred by Typhoon 21 in 2004. Collapse A was 3.0m in with, and 0.5m in depth. There was no spring in this collapse. Collapse B was 14m in width, 1.0m in depth. There was no spring in collapse B. The underground sound in collapse A and B were bigger than another positions.

Photo 10 Collapse in road cut slope B

Fig. 12 Distribution of the underground sound in road cut slope B

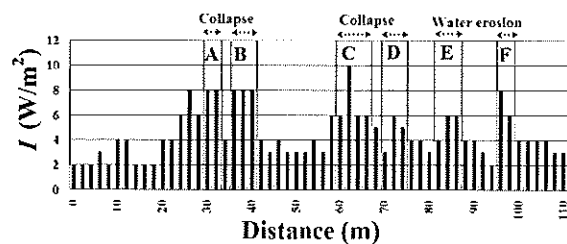
[3] Road cut slope C (photo 11, Fig. 13)

Four collapses and two water erosions were occurred in planting road cut slope. Collapse C and D was made by grating crib works. Collapse A was 2m in width, 1.0m in depth, and had no spring. Collapse B was 4m in width, 1.0m in depth, and also had no spring. Collapse C was 6m in width, 1.0m in depth. Spring water occurred in heavy rainfall event in collapse C.

Collapse D was 4m in width and 1.0m in depth. There is no spring in collapse D. Water erosions occurred in Position E and F.

Underground sound was big in each collapse positions and also big at position E and F that water erosion occurred

Photo 11 Collapse in road cut slope C

Fig. 13 Distribution of the underground sound in load cut slope C

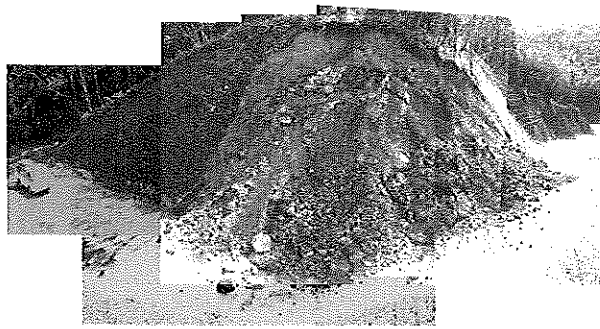
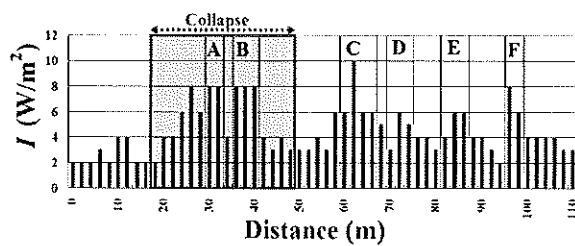
Appearance of load cut slope C after the typhoon was shown Photograph 12. The road cut slope was collapsed by heavy rainfall of typhoon. Photograph 12 indicated that Collapse was occurred in left side of grating crib works. Collapse was 30m in width, and 1.5 m in depth. This collapse position was collated with the underground sound distribution chart (Fig. 15). The collapse was occurred in the part that had three peaks of underground sounds.

Photo 12 Road cut slope C after the Typhoon

Fig. 15 Collapse position in road cut slope C

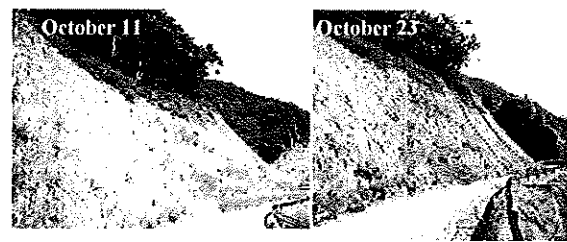
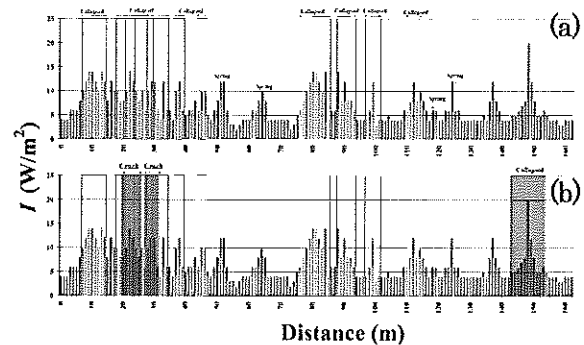
[2] Road cut slope D

collapsed by the heavy precipitation. Collapse was 10m in width, and 0.5m in depth. Figure 16(a) showed the underground sound distribution that measured before typhoon approached.

distribution of underground sound that was measured on July 12 2004 before typhoon approached. The pale hatch in figure showed the position where the collapse round had already been occurred on July 12, 2004. The dark hatch in figure showed positions in collapses and water erosions that were occurred by typhoon 23. Collapses occurred in big underground sound position.

The non-failure position that had big underground sound was collapsed by the typhoon. There is a part which underground water daily concentrates in the slope. And, water path position was collapsed by the groundwater that was supplied to torrential rains.

Photo 13 the appearance of road cut slope D before and after the typhoon approach

Fig. 16 Underground sound distribution and collapse position in road cut slope D
