Detection of Collapse Position in Mountainous Slope by Underground Sound Method

Synopsis

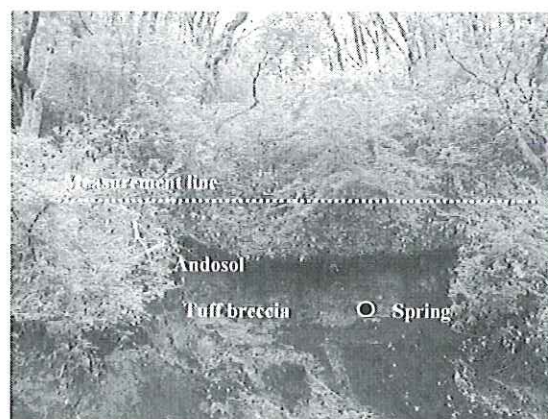
Photo 2 Soil exposure at the road cut in Hirusen A

[1] Hirusen A (Photo2) ; Spring position in forest road cut slope was inquired. Ground surface is covered with the andosol of 0.5 m in thickness. And the lower soil layer is composed of tuff breccia. There is one spring in tuff breccia soil layer. Spring occurred in heavy rainfall event or snow melting event. There were a few spring waters when the investigation was executed.

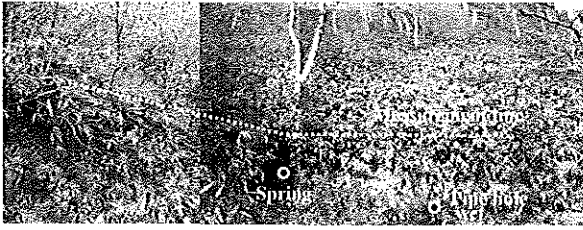
Photo 3 Soil exposure at the road cut in Hirusen B

[2] Hirusen B (Photo3) ; Two spring position in forest road cut slope were inquired. Ground surface is covered with the andosol of 1.5 m in thickness. The lower soil layer is composed of tuff breccia. There are two springs in road cut. One spring in andosol layer (spring A) has a few discharge when road cut slope were inquired. Another spring existed in tuff breccia

soil layer. This spring B has few discharge when road cut slope were inquired.

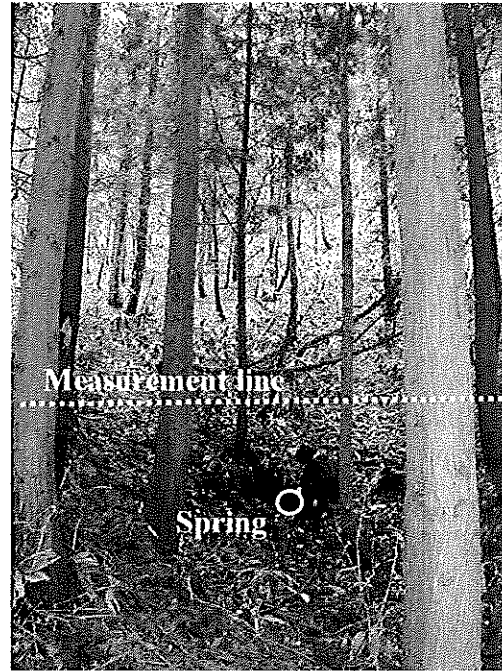
Photo 4 Condition around the spring in Hirusen C

[3] Hirusen C (Photo4) ; One spring position in bottom of the slope were inquired. Ground surface is

covered with the andosol of 2.0 m in thickness. The lower soil layer is composed of tuff breccia. There was the spring in andosol. And, spring occurred in heavy rainfall event or snow melting event. This spring has not discharge when slope were inquired.

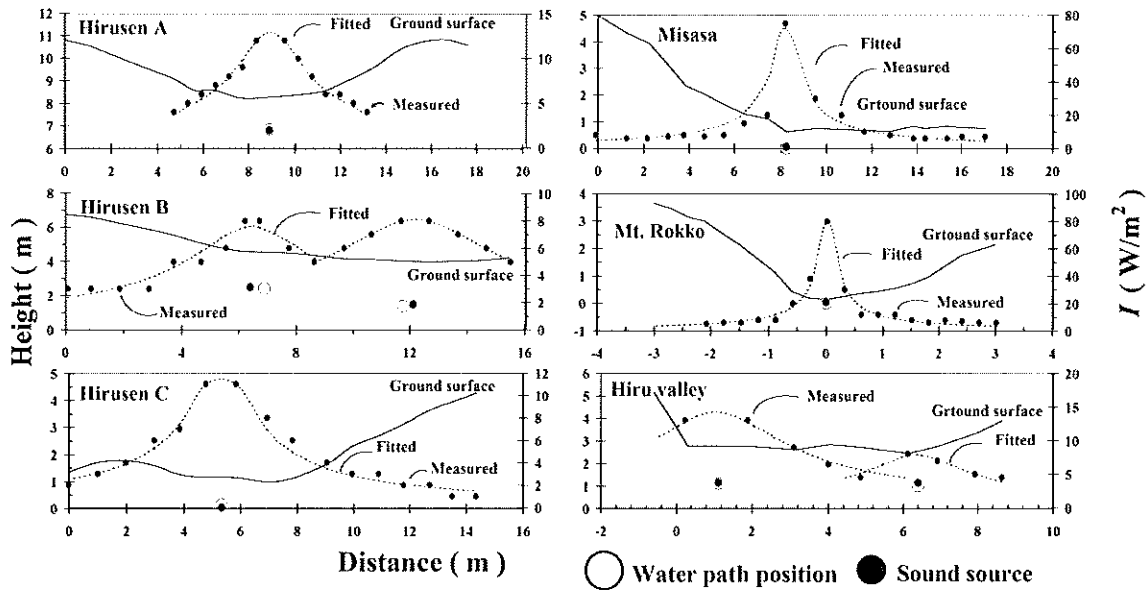
Fig. 6 Measurement results of underground sound and calculation results of water path position

In all sites, underground sound was biggest on the spring point. And underground sound in measurement point has become small while going away from the spring point. This tendency is the same in case of two or more spring water exist.

These results in natural slope conformed to experimental results. And, It is interesting that there is a sound peak in the position where spring was not seen (Hirusen B, C).

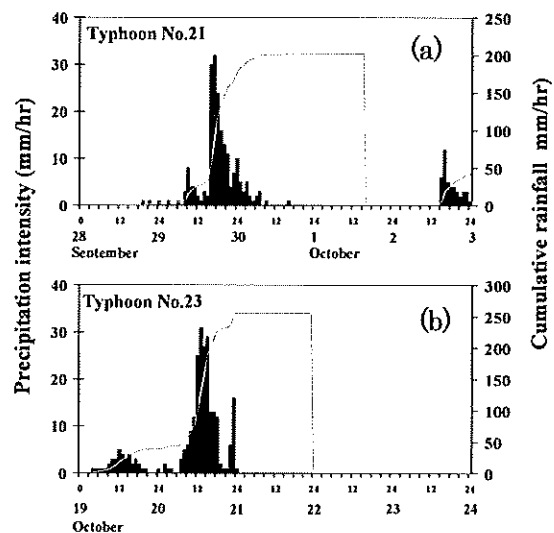
Fig. 14 Rainfall intensity and cumulative rain precipitation

Figure 14(a) showed the appearance of precipitation. Peak of rainfall intensity was 30mm/hr. Cumulative rain precipitation was recorded 200mm.

The underground sound was measured on July 12 in 2004. After measurement, Typhoon No. 23 brought heavy rainfall in Tottori and Okayama aria on October 20-21, 2004. Figure 14(b) showed this precipitation result. Peak of rainfall intensity was 30mm/hr. Cumulative rain precipitation was recorded 250mm. Photograph 13 showed the appearance of road cut slope D before and after the typhoon approach. Cut slope was
